Manhole Inspection Summary

Manhole # S09WW1002MH

Insp Date: **7/14/06 11:05 AM**

Location Address: **2808 WOODCREST AVE**

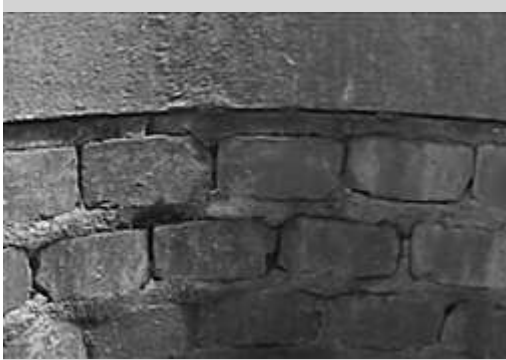
Defect

Condition: ☐ Sound ☐ Cracked ☐ Root Intrusion ☐ Loose Brick ☒ **Deteriorated**

Infiltration: ☐ None ☒ **Joint** ☐ Cracks ☒ **Mortar** ☐ Roots ☐ Wall

Frame leaks. Adjustment deterioration and infiltration.

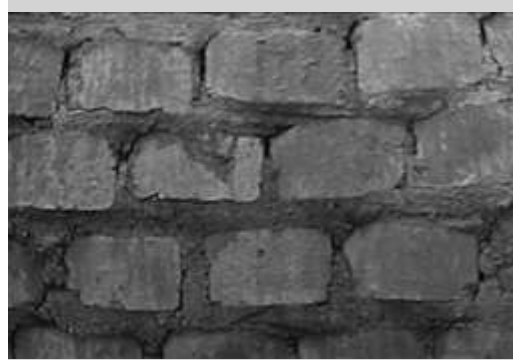
Defect

Condition: ☐ Sound ☐ Cracked ☐ Root Intrusion ☐ Loose Brick ☒ **Deteriorated**

Infiltration: ☐ None ☐ Joint ☐ Cracks ☒ **Mortar** ☐ Roots ☐ Wall

Corbel deterioration and infiltration.

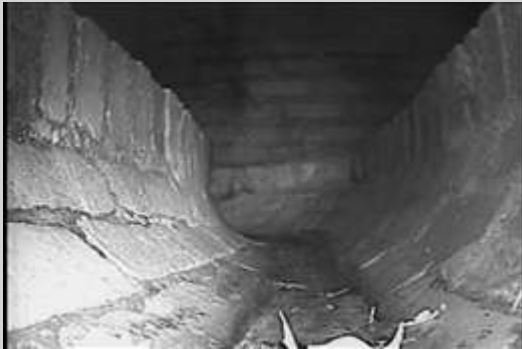
8 in. Circular Gravity Sewer Pipe Out @ 12 O'Clock

channel has no top for a few feet

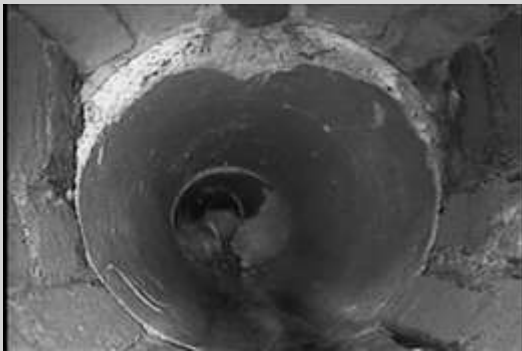
10 in. Circular Gravity Sewer Pipe In @ 3 O'Clock

Infiltration: **Evidence**
